# Saving the Historic Hevra Synagogue of Izmir

## A Case for Support

## Interim architectural Report on Hevra Synagogue September 2016

### ***Hevra synagogue, a description of current situation and recommendations for urgent rescue work.***

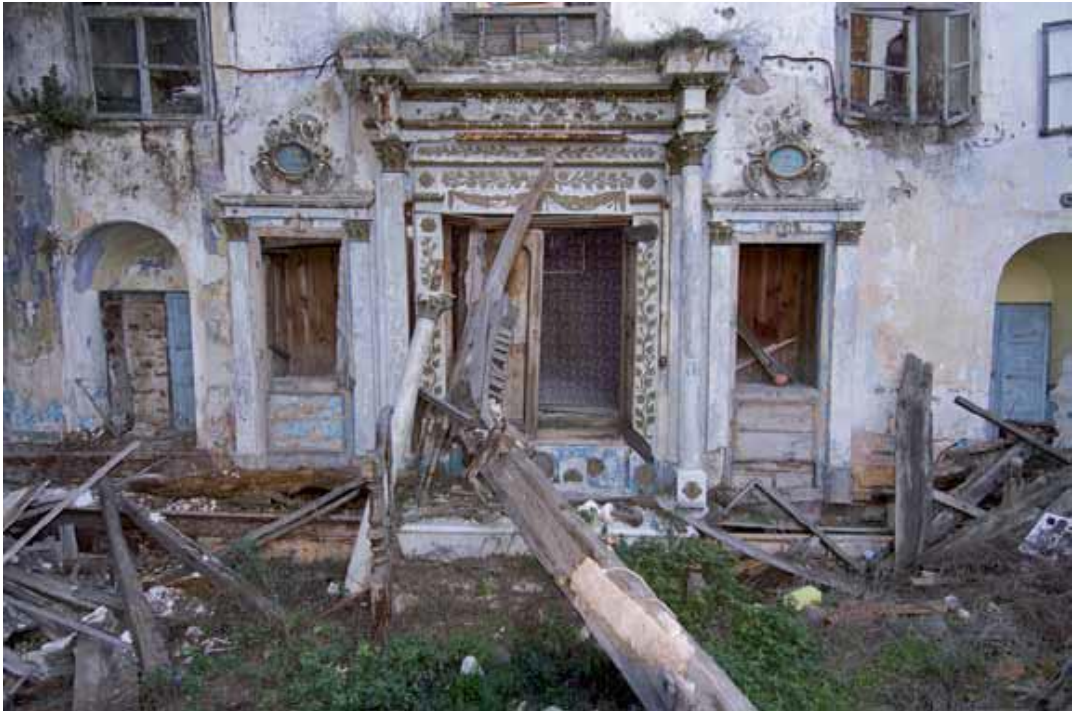
**Hevra Synagogue after it collapsed**

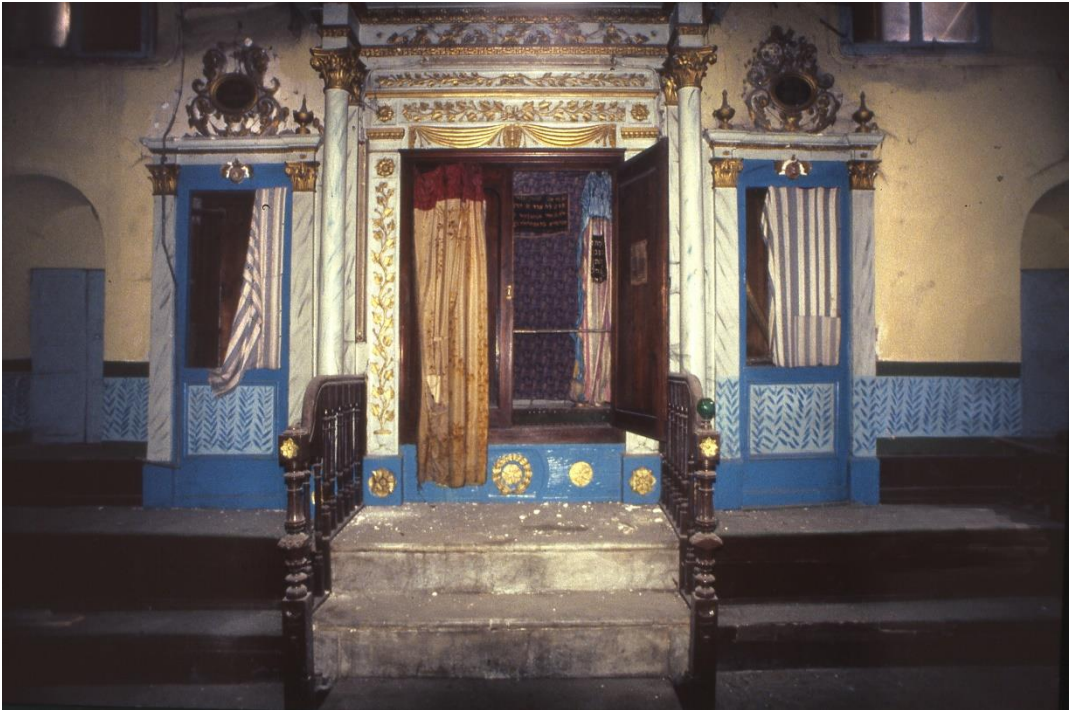
**Hevra Synagogue before it collapsed**

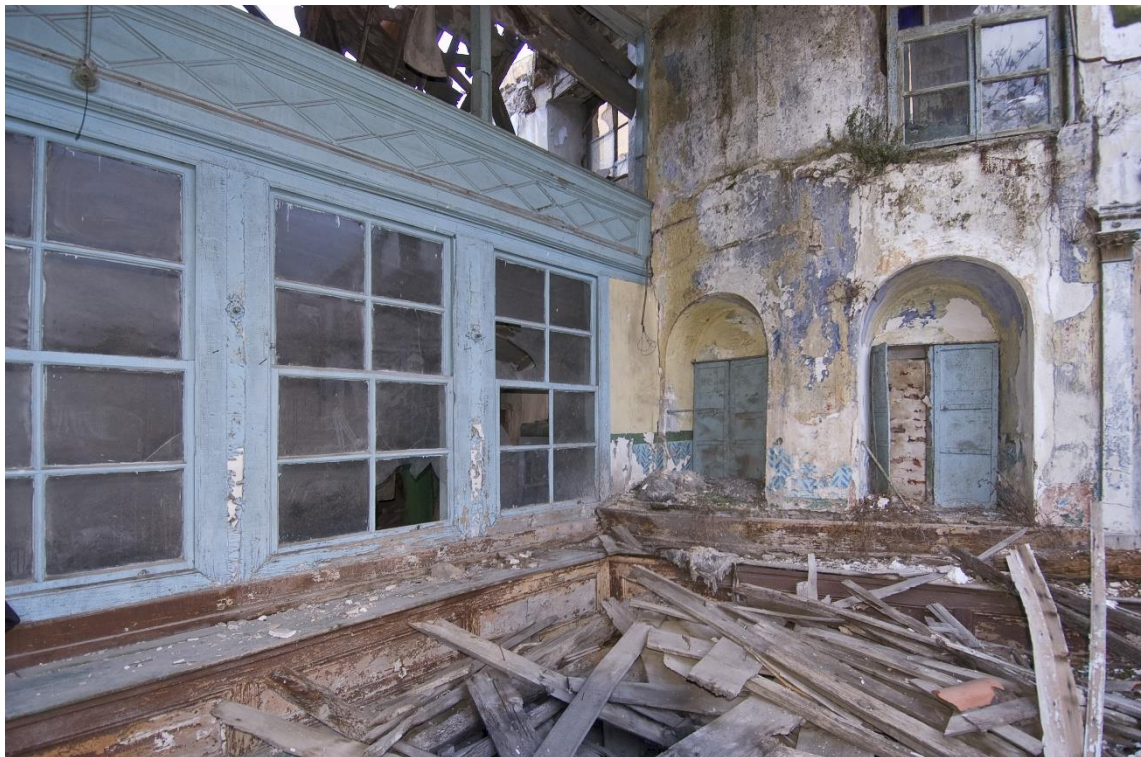
The ' Beit Midrash' (school) at the Entrance of the Synagogues was also destroyed. Only the four walls of the main prayer hall with remnant of the Holly Ark remained half ruined. Most of the walls and the beautiful wall-paintings were damaged.

The Synagogue had in the past a beautiful courtyard, that was filled up during the years with shops. These shops probably will need to be removed during the restoration work in order to reveal the Synagogue's beautiful original courtyard.

Yet, since the plans and documentation of the Synagogue that was done in year 2000, are in hand, it is still possible to restore this originally beautiful and important Synagogue and renovate it to its original condition.

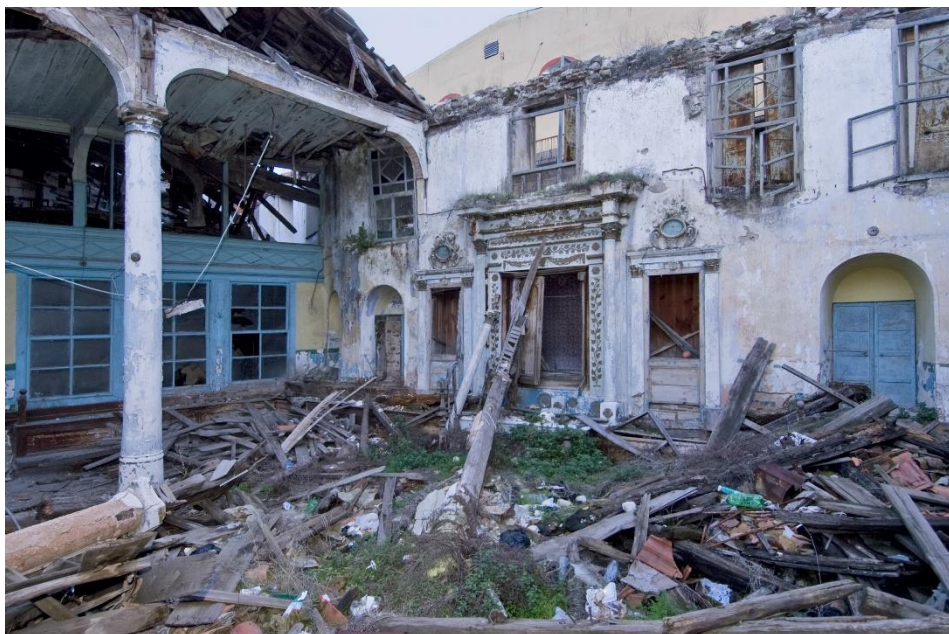
The building is dilapidated. There is no roof at all, the pillars have fallen down, the “Aron Kodesh” and the walls are in a very bad condition. The Synagogue is exposed to weather changes. Yet the “Beit Midrash” space is not completely destroyed.

The building is of masonry. The pillars, the roof, the ceiling, and the “Bimah” are made of wood. The floors are covered with ceramic tiles. It is not easy to recognize the unique elements in the synagogue, because of the bad condition of the building. Nevertheless, the main elements are:

- The roof does not exist
- Unique elements are exposed to weather changes.
- The pillars, floor, and walls are in very bad condition
- The gallery above the entrance space should be taken care of.

We can recommend that, before reconstructing this building, we must protect the special elements such as the “Bimah”, “Aron Kodesh” and other furniture by temporarily moving them to other spaces. If possible, a protective roof can be added in order to protect the walls and the interior of the building. The gallery should be supported by pillars.

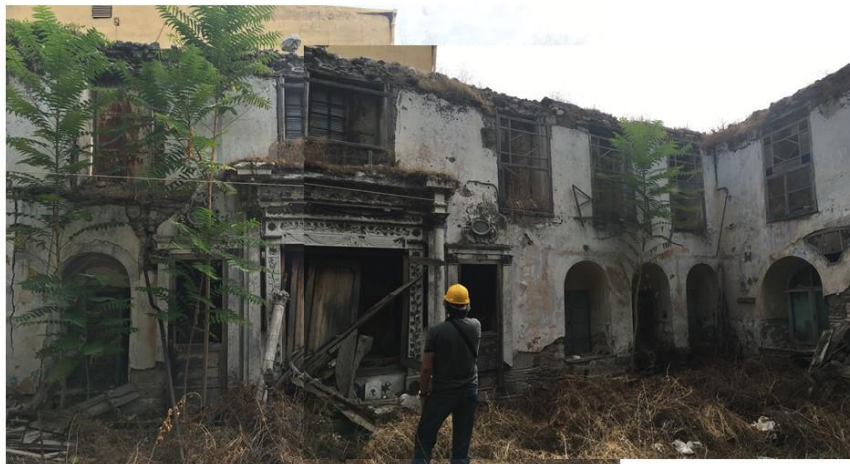
Photo of Haychalot wall including the remains of the Holy Ark, including details of the original entrances including windows and shutters, wall decorations and many other decorations in wood and drywall that are in critical condition.

- Implementation of defragmentation and repair of the Heychalot wall including examination by a specialist constructor, Implementing immediate solution includes support to prevent collapse and making 'Sewing' of the crack by filling with mortar (Bonding material) and stone for closing the gap and if necessary, installing anchors strengthening and stabilizing of the two parts of the walls.

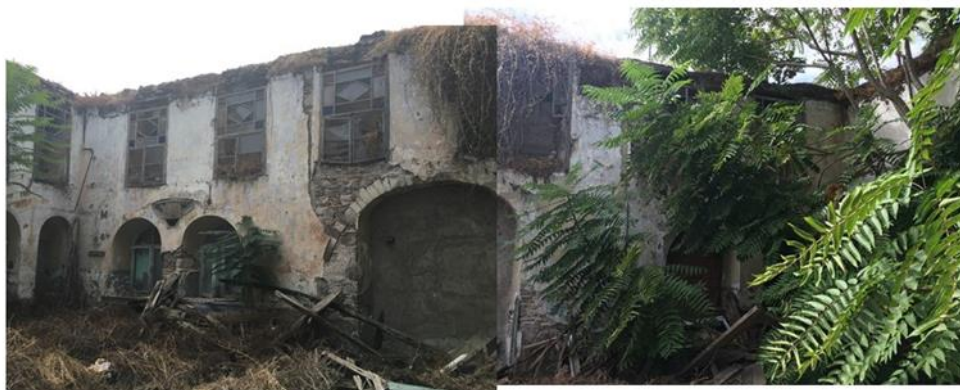
Southern elevation which includes a deep niche which may have served as another entrance to the synagogue, the remains of entries with stained glass windows and original shutters, wall decorations include paintings, wood and drywall decorations.

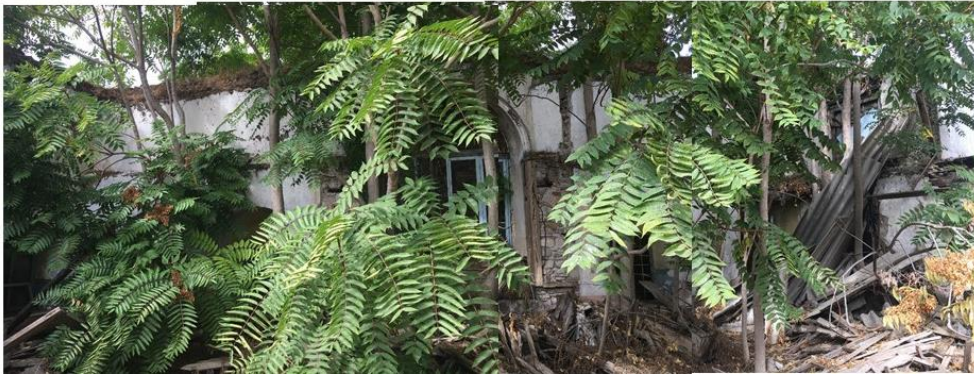
The western facade of the synagogue has high niche that is a unique architectural element to this specific synagogue, the niche is decorated with rich detail.

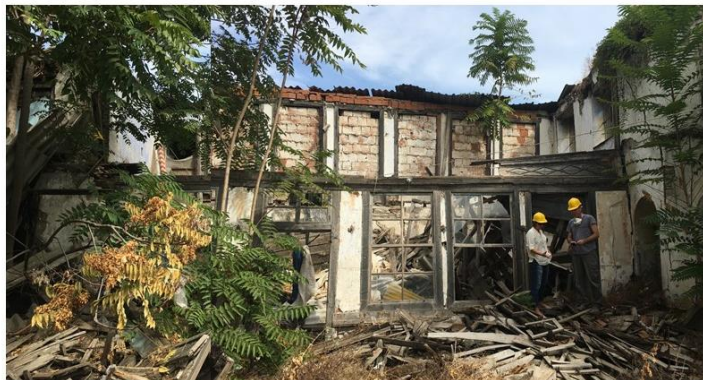
North facade of the internal building structure which includes the ruins of the Beit Midrash (recently collapsed), in this photo decorated wooden partition (typical to Izmir synagogues such as Elgazi, Ets Haim, Bikur Holim) where it is tilted before the final collapse.

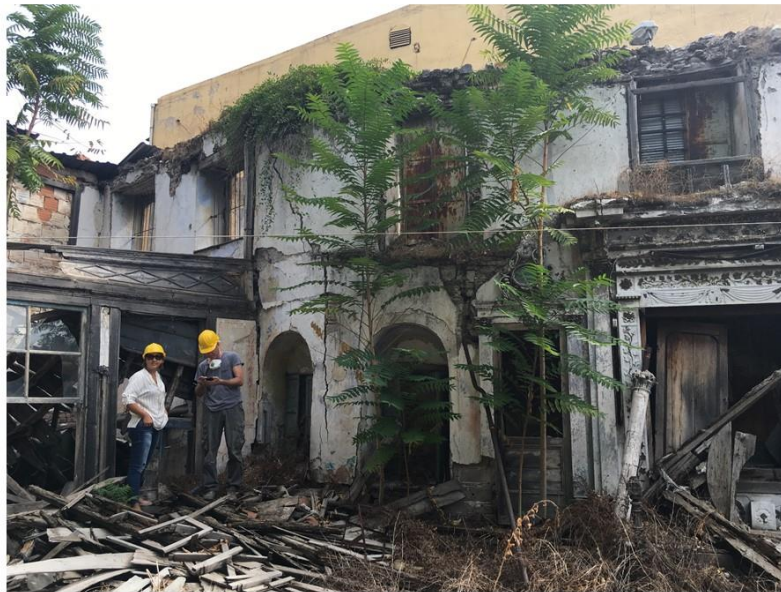
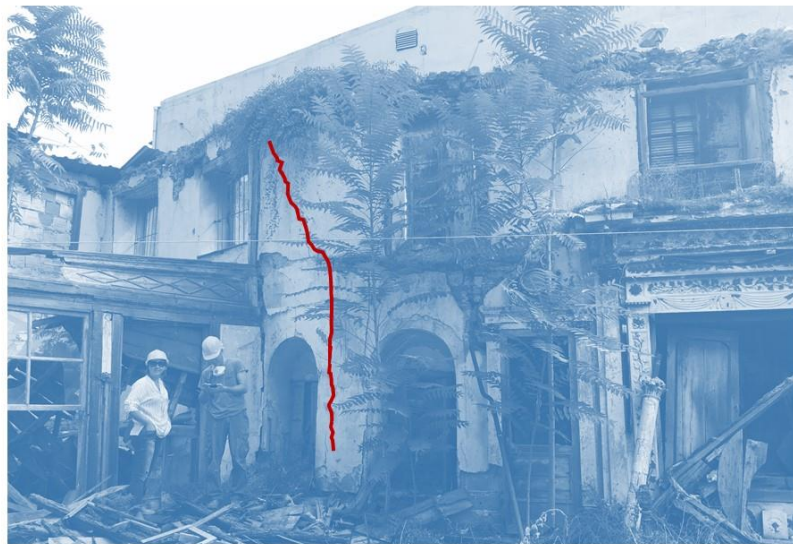
A look at the Heychalot wall including the northern entrance area, the photograph highlights the broken wall that extends from the top of the wall endangers the stability of the entire wall, the risk of fracture crack developing into building collapse is high.
